South African Maritime Safety Authority

Marine Notice No. 7 of 2020

Lessons Learned from a recent fuel oil spill in port

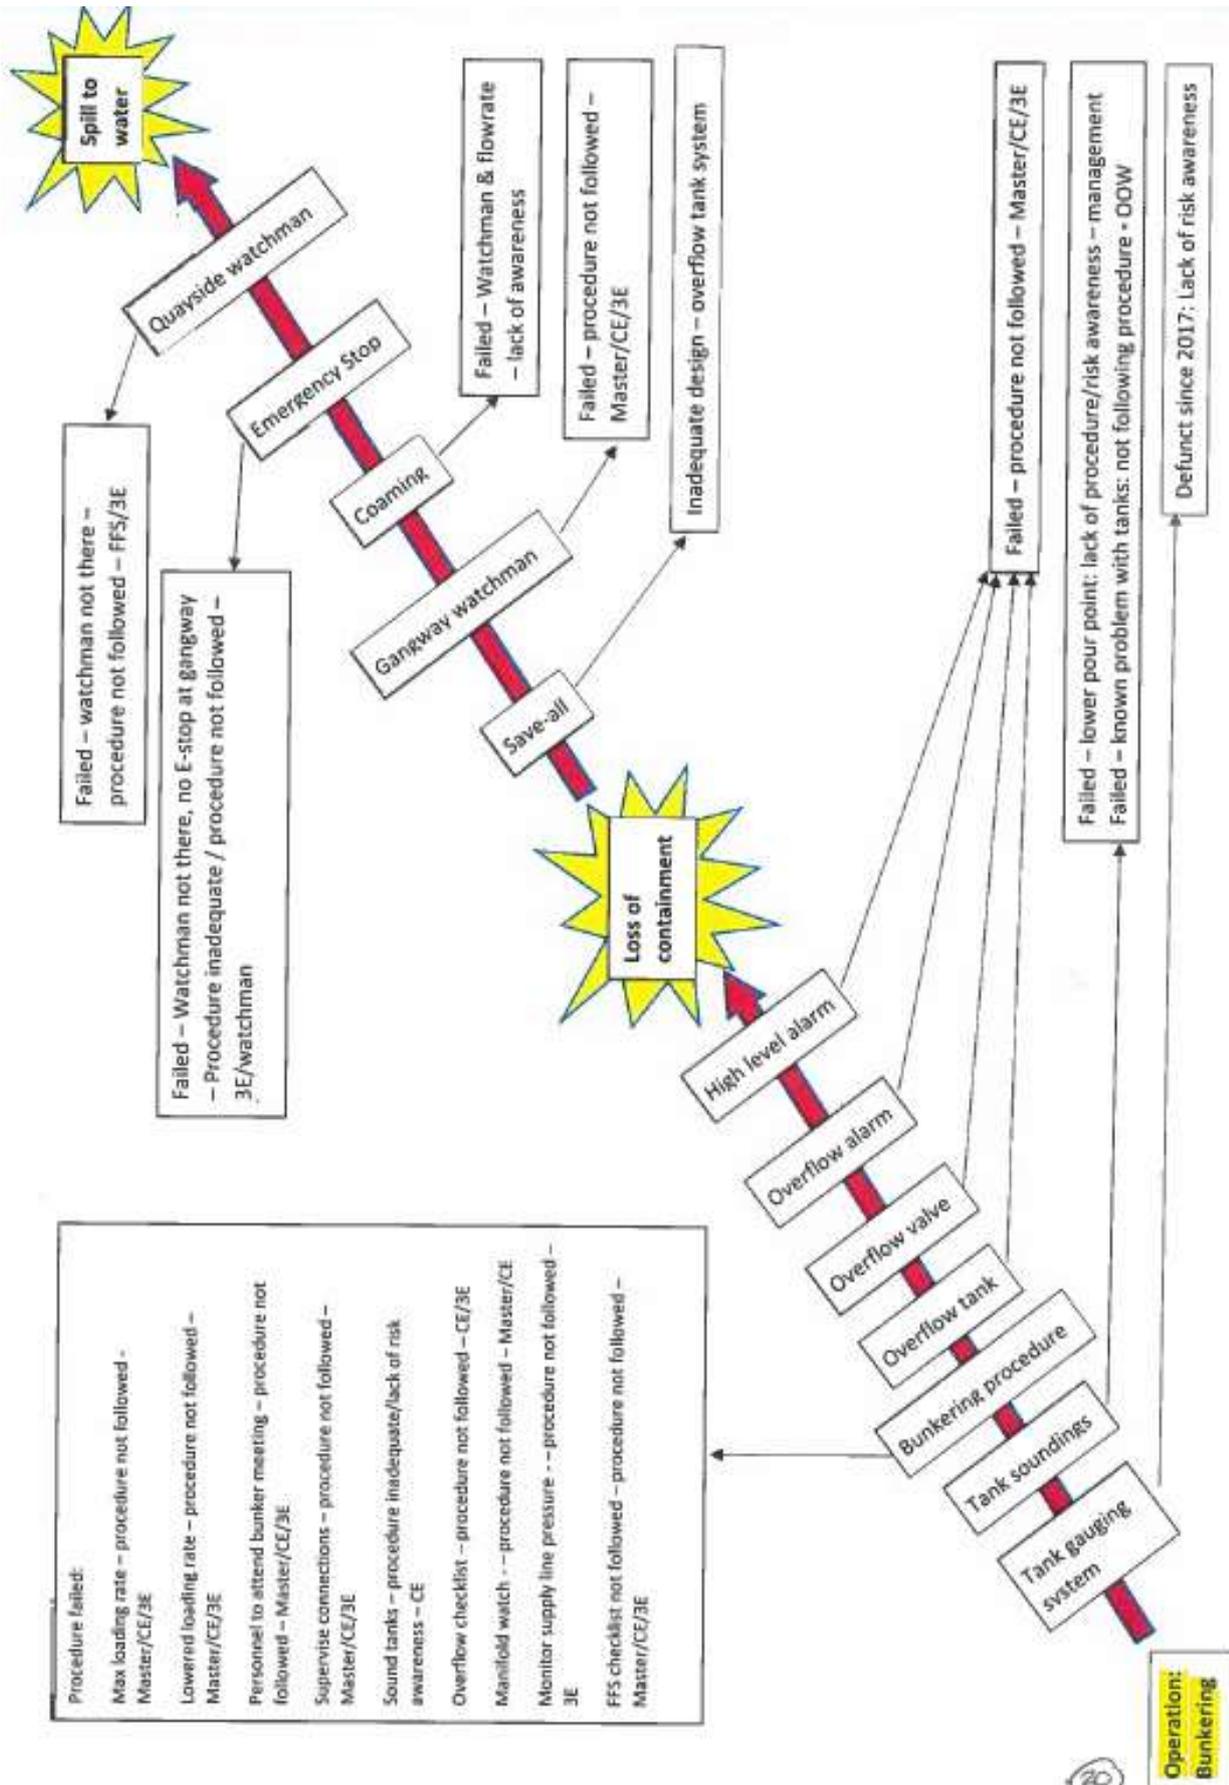
Bowtie analysis of the barriers that broke down:

There were several direct and indirect causes contributing to this event. There were also several barriers specifically designed to prevent pollution that broke down, due largely human elements.
