PILOT LADDER SAFETY - LESSONS LEARNT FROM INCIDENTS WHERE EQUIPMENT FAILURE WAS DEEMED TO HAVE PLAYED A PART.

ISSUE DATE	07 May 2021	EXPIRY DATE	Indefinitely or unless withdrawn	REFERENCE	SM6/5/2/1/MA
-------------------	-------------	--------------------	----------------------------------	------------------	--------------

SUMMARY

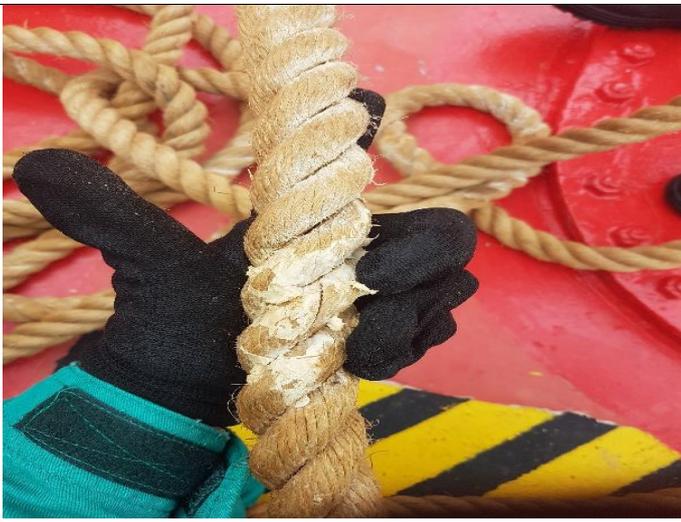
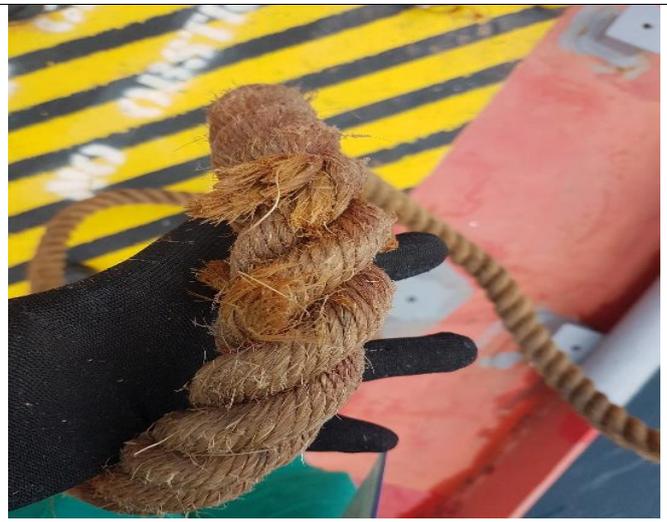
Incident 1: Occurred on a vessel leaving the Port of Durban on 28 April 2020.

Upon confirmation from the Master of the vessel that the pilot ladder was rigged, the Pilot proceeded down to the ladder. Pilot then climbed down the ladder prior to the launch coming alongside. While the Pilot was climbing down, one of the MAN ROPES parted which resulted in the Pilot losing his balance on the ladder and subsequently falling into the water.

Upon investigation it was found that the ladder had a white chemical residue on it. It is suspected that this residue might have contributed to the deterioration of the rope and eventual parting. It was also found that the on board records of inspection indicated that the ropes were in good condition.

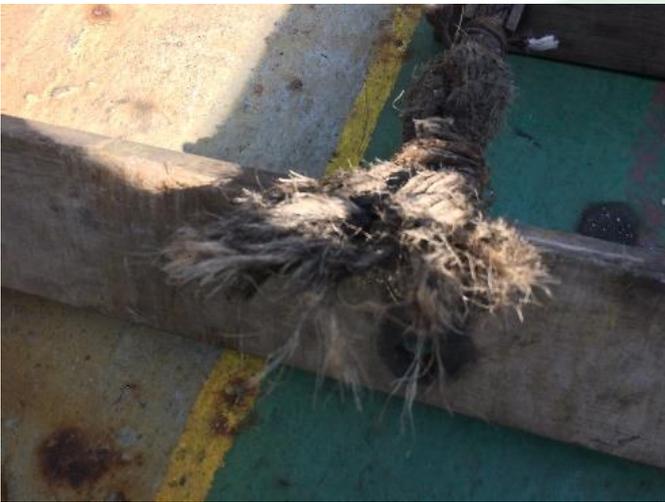
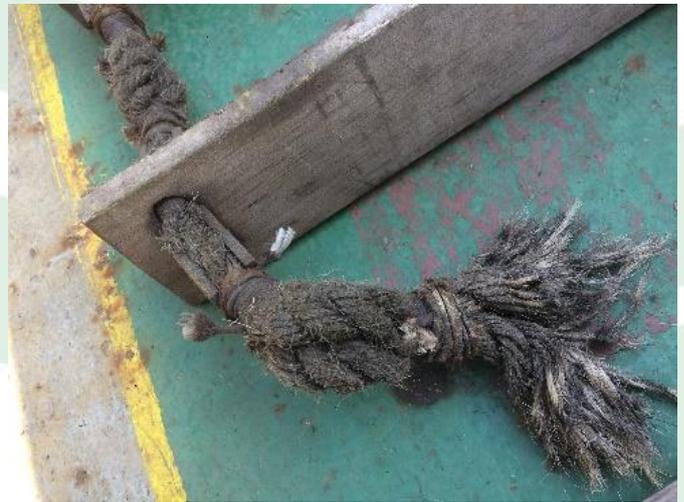
Incident 2: Occurred on a vessel in the approached to Durban harbour on 16 September 2020.

The pilot ladder parted causing the pilot fall onto the deck of pilot boat.

Investigation outcome found that vessels maintenance plan and purchasing system showed the ladder was deemed not fit for use in their monthly inspection and a new pilot ladder was purchased and was to be received in Durban. It appears that the cause on the incident was the fact that the vessel did not take the defective pilot ladder out of service and failed to ensure the ladder was fit for use.

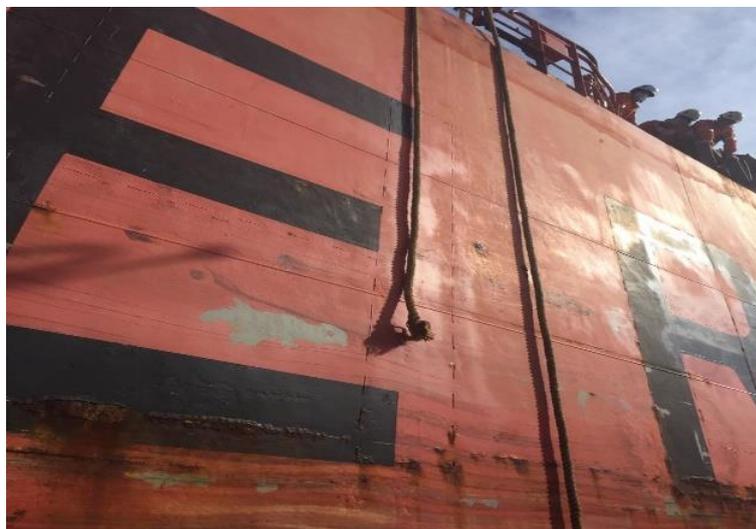
Incident 3: Occurred on a vessel in the approached to Durban harbour on 26 October 2020

One MAN ROPE parted resulting in a pilot falling onto the pilot boat deck while disembarking at the pilot station. The Pilot was taken to the hospital.

During the Investigation it became apparent that there was no MAN ROPE specific maintenance required in the ship maintenance system. It was assumed that the person doing maintenance on a pilot ladder will also inspect the man ropes.

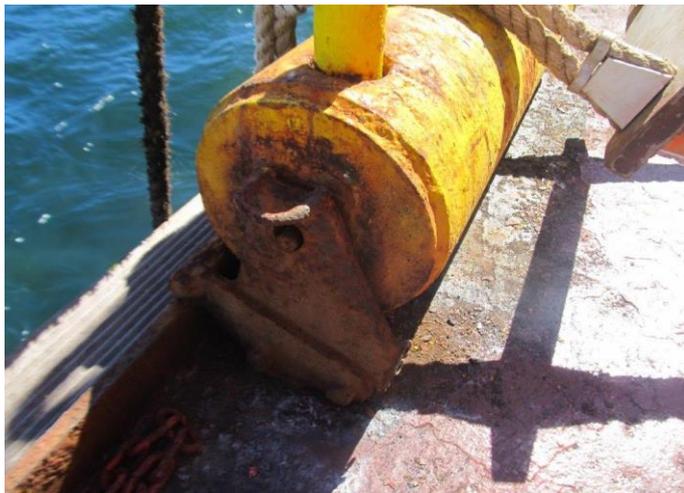
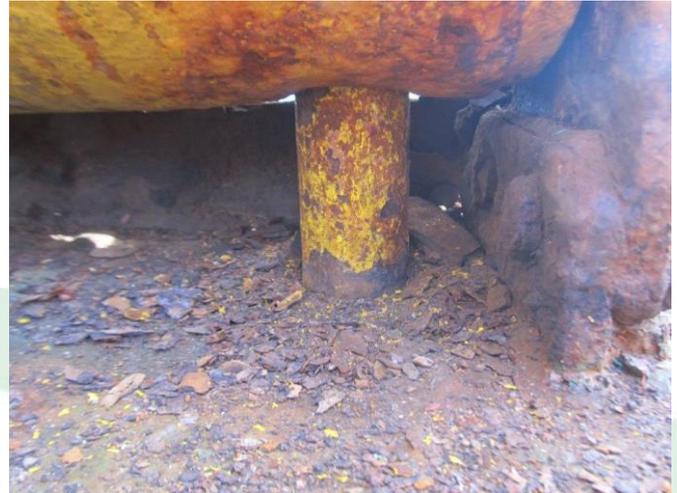
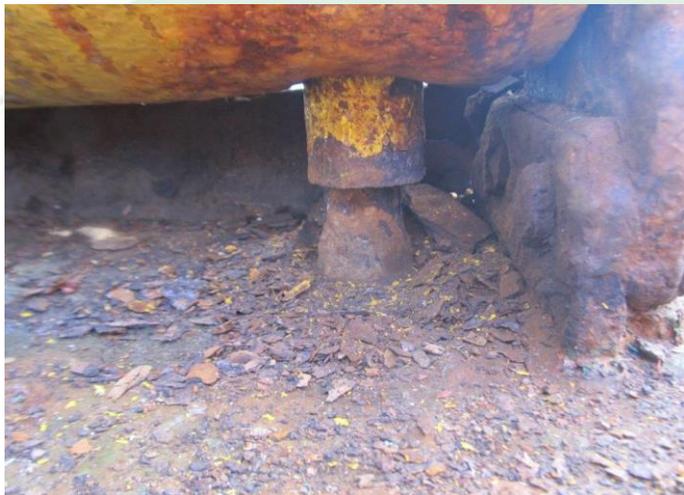
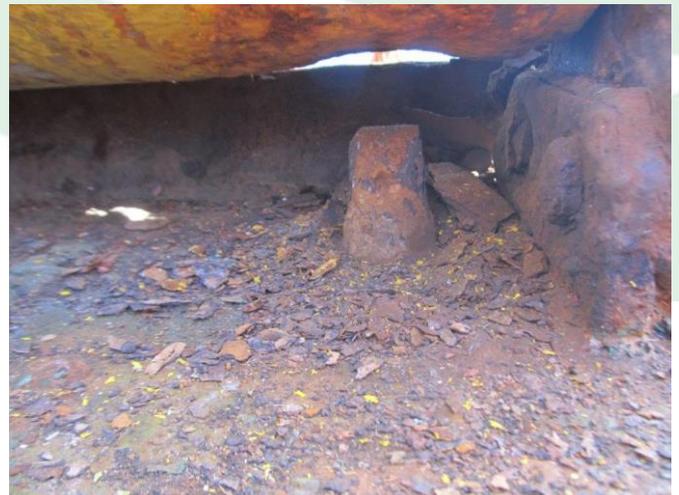
Incident 4: Occurred on a vessel at anchor in Algoa Bay at number 2 anchorage on 21 November 2020.

1. a) The stanchions initially appeared to be very securely located in a deck mounted roller of 200mm in diameter.
b) On closer investigation it was found that the lower part of the stanchions was not secured but were held in place by merely fitting it over a horn welded to the deck.

c) Due to apparent lack of maintenance of the horn below the deck mounted roller, corrosion had caused the horn to reduce in thickness making for a loose fit inside the stanchion.

2. a) The 4th crew member was reportedly nervous of the climb down the ladder. Witnesses to the incident stated that his body stiffened up when he stepped onto the ladder before he started his climb down the ladder. It appears that this stiffening up of his body might have caused him to pull the stanchions right out of the securing horns. This in turn caused the roller with the stanchions to rotate 90 degrees towards him causing him to lose his balance and falling backwards into the water.
