### RUDDER MODIFICATION ON PLEASURE YACHT LEADS TO LOSS OF VESSEL

<b>ISSUE DATE</b>	20 June 2021	<b>EXPIRY DATE</b>	Indefinitely or unless withdrawn	<b>REFERENCE</b>	SM6/5/2/1/MA
-------------------	--------------	--------------------	----------------------------------	------------------	--------------

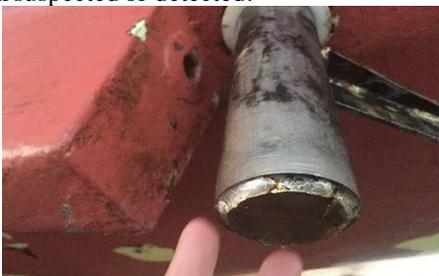
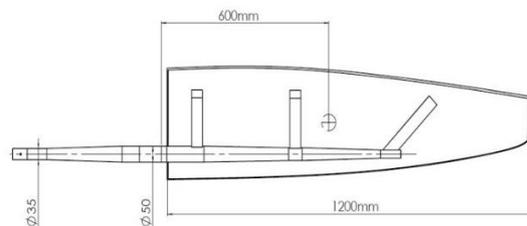
The rudderstock had been modified at an undetermined time in the past and the weld modification was insufficient to withstand the forces experienced during the heavy weather after exiting the port of East London. Rudderstocks are usually solid tapered stainless steel as per the diagram, from a uniform material, with no welds or joints. If a joint or weld was introduced at a later stage, the preferred methods of modification would be either a keyed flange / keyed taper flange arrangement, or a fully welded flange, all of which should be of sufficient, calculated dimensions to withstand effects of the transmitted torque. This modification should be evaluated by a competent Engineer and a suitable signed document attesting to this must be provided. The owner and SAS surveyor had been aware of the modification, but because it was not visible at the time of survey, no defect had been suspected or detected.

SAMSA wishes to advise all owners of vessels with similar modifications to rudderstock to have the stock checked if in doubt. The original design of having a solid rudderstock is the best solution should a rudder need replacement.
